AMATEUR BOAT BUILDERS' ASSOCIATION

October November 2021

AN ABBA TOOLBOX VISIT ON ANOTHER LEVEL

SHOW & TELL

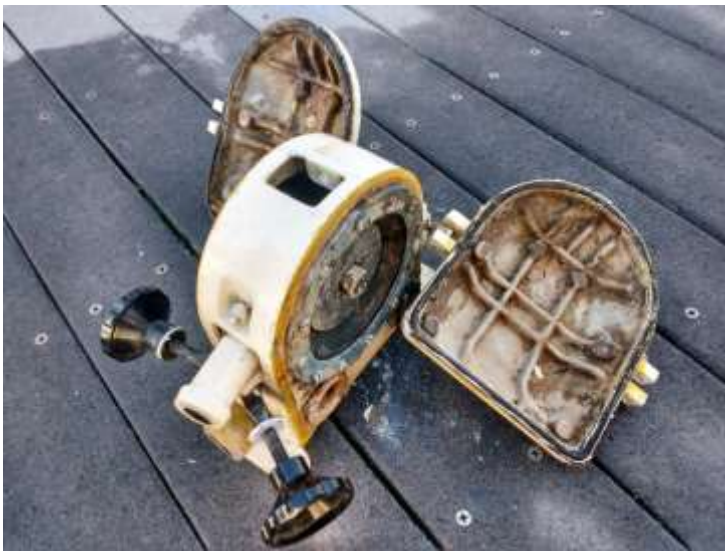
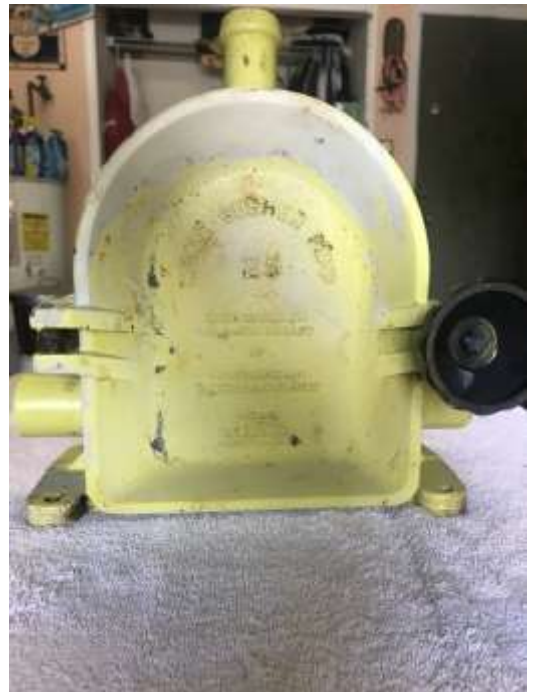
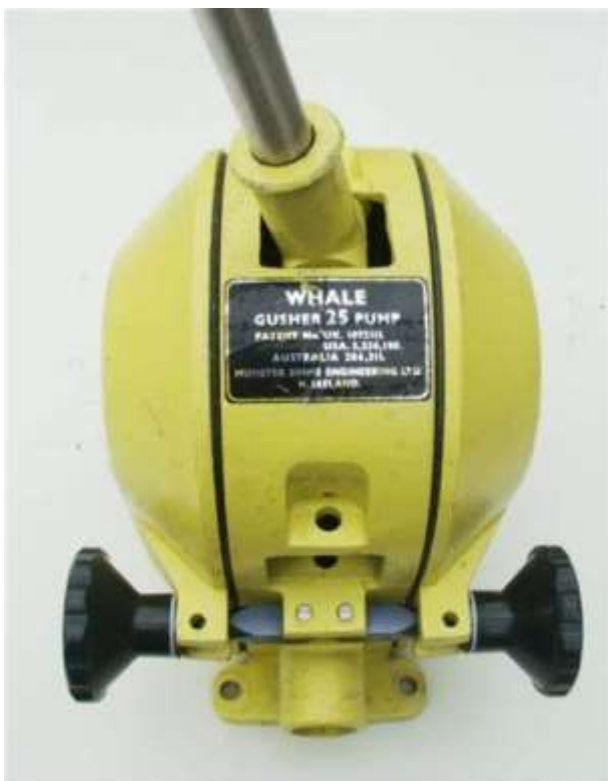
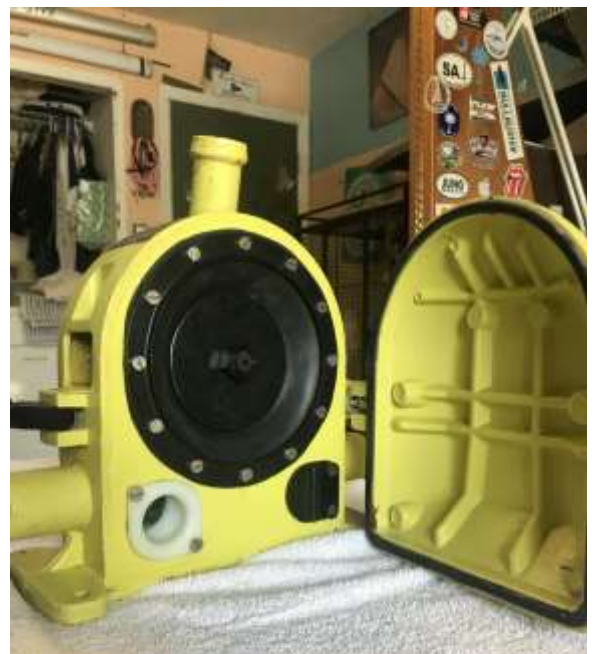
Ed Essers - Ed bought in an old Whale Gusher 25 double acting Bilge Pump that a friend gave him. He showed us the pump and told us how it worked and about its many good features. It needs a lot of cleaning up, but parts are still available for it and Ed is confident it will work again. Whale Marine are still based in Bangor, Northern Ireland where this pump was made. Ed had a similar Whale Gusher on his last boat and can attest to its simplicity, reliability and high capacity.

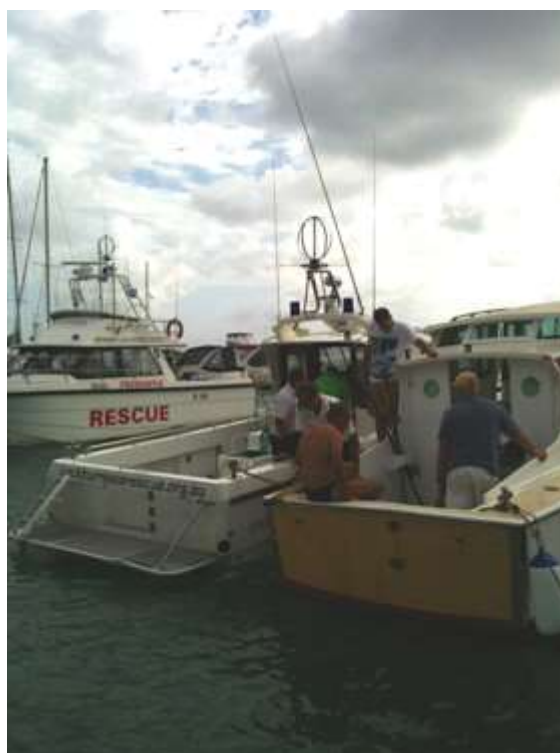
Rob managed to seal up most of the leaks and the 200 gph bilge pump was cutting in about every 15 minute which led to it being given the name "The Water Feature". Rob was using an automatic Rule float switch rated at 14 Amps. With a 24 Volt system, the bilge pump was drawing 6 Amps so it should have been fine. Rob went through 3 or 4 float switches that failed in service. He then bought a 20 Amp float switch that has worked fine since. Rob felt that the problem wasn't the current going through the float switch, but the number of times that it operated due to the continuous leakage of water into the boat. Rob thought that these cheaper float switches have a finite number of cycles before they fail.

Rob later installed another bilge pump in the aft section of the boat as the ribs every 2 feet apart with narrow drainage passages meant that it took some time for water entering at the back to make its way to the pump at the front. He recommended installing an aft bilge pump right up against the transom as water collects here while under way and ideally it shouldn't be allowed to accumulate in this location.

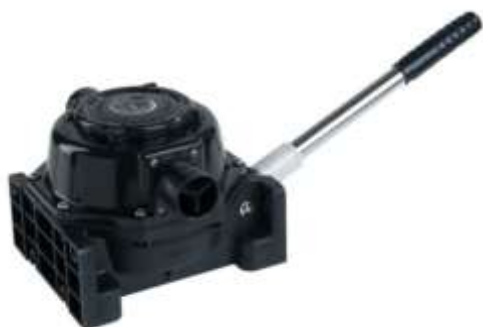
Henderson Mark 5 Bilge Pump

Chris Davis—Chris bought in a Henderson Mk 5 bilge pump which he said was a bit similar to Ed's Whale Gusher pump and felt it was a good bilge pump despite being made of plastic. It also had a label showing it was made in Bangor. Chris was right as Google tells us that Henderson is made (or owned) by Whale Marine in Bangor Northern Ireland.

When Chris purchased his current boat, it had a Henderson Mk 5 installed. He suspected a blockage or fault with the pump as it only moved a very small amount of water with each stroke of the handle. The pump is simple to open up to remove any debris and the non-return valves are easy to remove for service or replacement but this wasn't the problem. Connected to the end of the suction hose was a Strum Box or suction strainer. The one on Chris's boat was fabricate from stainless steel and looked well made but the diameter of the barb where it connected to the suction hose was only about 3/8" (10mm). The end of the hose had been greatly reduced to make it fit the small barbed connection and severely reduce the capacity of the pump. The lesson here is to get the basic engineering correct and avoid reducing down from the size of connection on the pump.

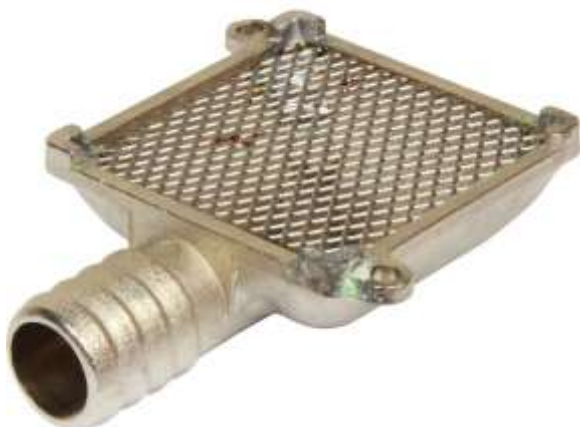
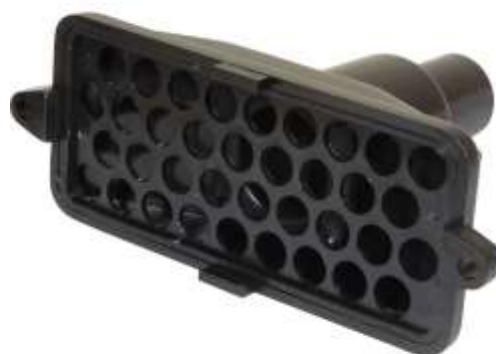
Examples of metal and plastic strum boxes

Chris also mentioned the need to use a proper suction rated hose to avoid it collapsing when being used. Chris now successfully uses a plastic Strum Box but the disadvantage is that the plastic floats and needs to be weighed down in the bilge.

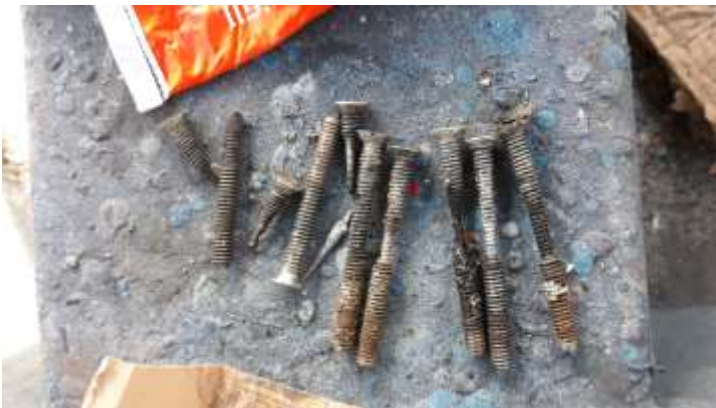
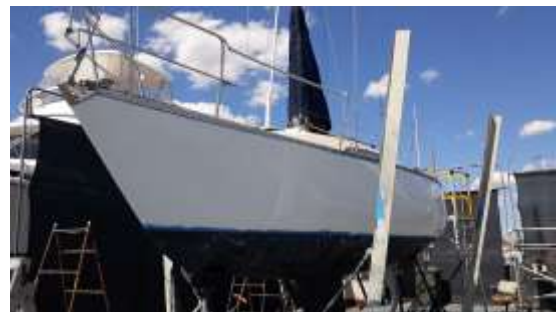
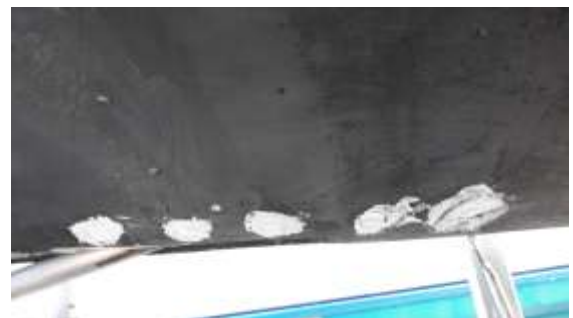
Bruce Cadee showed some photos of corroded bolts that were securing the prop shaft bearing support on Bob Harrap's Cole 26ft fiberglass yacht. They were possibly around 40 years old. The countersunk bolts that had been put in through the hull from the outside and then covered with epoxy before applying anti-fouling.

Bruce Uren – Bruce shared his experience with corrosion of the stainless steel bolts securing the rudder gudgeon at the water line on his SpaceSailer 22. Stainless steel relies on a very thin stable oxide layer for corrosion resistance and is good when exposed to the weather above the waterline but slowly corrodes overtime when fully immersed, especially in areas deprived of oxygen which prevents the oxide layer from forming.

Bruce passed on a tip for securing fittings to the top of a fiberglass deck or cabin top with countersunk stainless steel bolts. Rather than fill up the complete hole with sealant, form a seal around the underside of the countersink on the bolt and secure from below with a nut. This will allow any water that does get in to drain out and will allow oxygen in to avoid corrosion.

316 grade stainless steel contains chromium, nickel and molybdenum. It is the molybdenum that helps prevent chloride attack. Other grades of stainless steel like 304 do not contain molybdenum and should not be used in a marine environment. Sources of 316 ss fasteners are Austain in Belmont but they can be pricy and only sell in large quantities. West Coast Fasteners in Balcatta sell in small quantities at better prices. 316 fasteners can be found in boat hardware stores and even Bunnings but ensure it is labelled 316 and not just stainless steel.

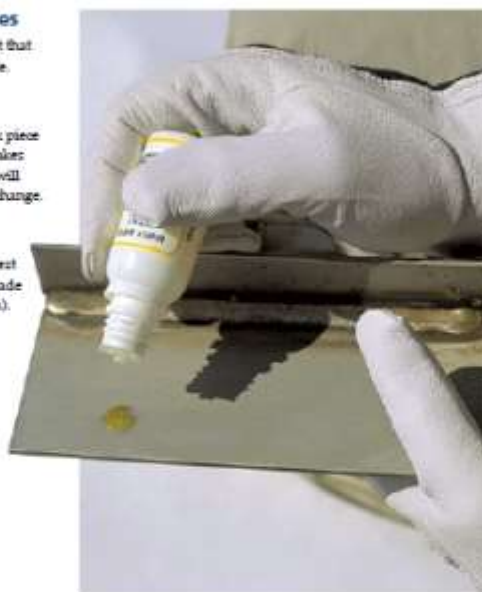
Easy identifying of stainless steel grade with Avesta Moly-Drop Test 960.

Avesta Moly-Drop Test 960 is an easy to use chemical test that helps differentiate 304 grade stainless steel from 316 grade.

With this simple chemical test you can check if your stock piece or scrap of stainless steel contains Molybdenum. This makes it possible to differ the steel grades 304 and 316. The test will identify the grade within 5-10 minutes through a colour change.

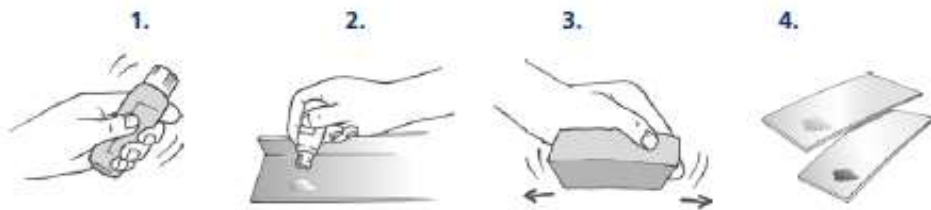
Instructions for use

1. Shake the bottle well before use.

2. Apply 1-2 drops and wait 5-10 min.

3. Rinse thoroughly with water.

4. No colour change = grade 304.
Colour change to dark brown = grade 316

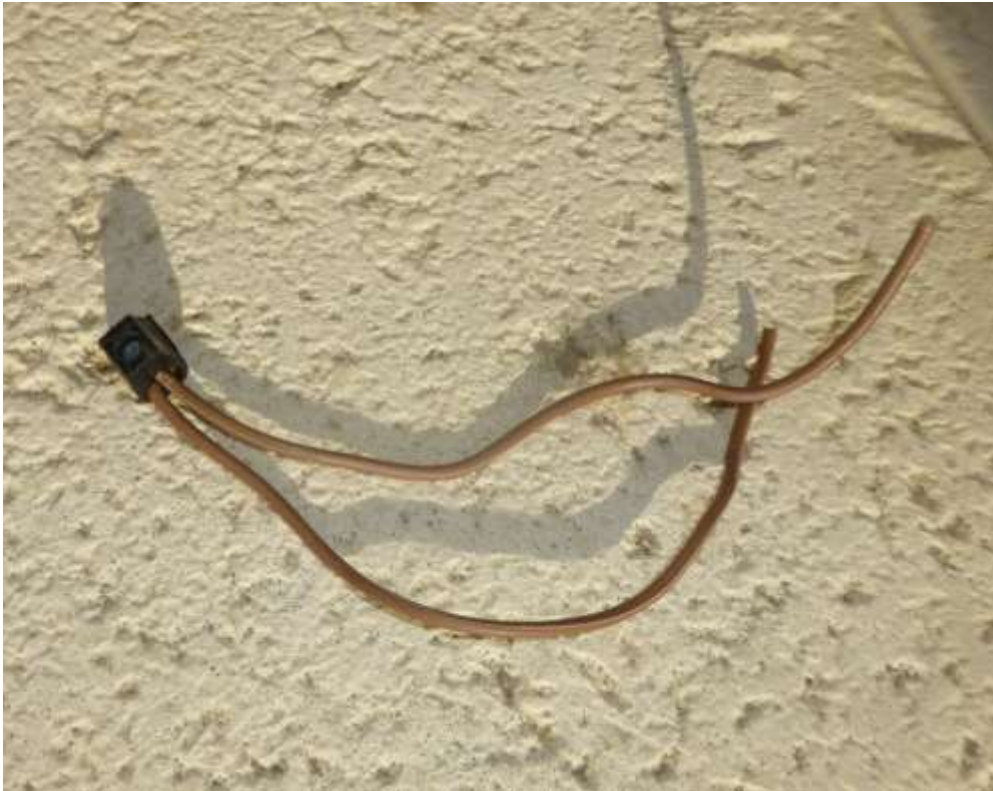
Bruce Cadee told the saga of his trip from Maylands in a timber boat after having it out of the water for 10 days in warm weather. It started taking water but the single 500 gph bilge pump initially seemed to manage though after a while it stopped. He kept motoring, bailing and operating the bilge pump but eventually needed a tow back to his mooring in Bull Creek. The cause of the bilge pump failure was a short circuit when the water level rose high enough to reach the household electrical wiring connectors located out of sight under the engine. The lesson was if you didn't build the boat yourself, take the time to inspect the bilge pump wiring after purchasing it and don't assume the previous owner had done a professional job. Bruce subsequently added a second, independent pump, float switch, battery and solar panel, all with proper connections.
